USAAMRDL TECHNICAL REPORT 71-50

**BALLISTIC VULNERABILITY OF BORON/EPOXY
DOUBLE-WALL DRIVE SHAFTS**

October 1971

CONTRACT DAAJ02-71-C-0021
SIKORSKY AIRCRAFT DIVISION
UNITED AIRCRAFT CORPORATION
STRATFORD, CONNECTICUT

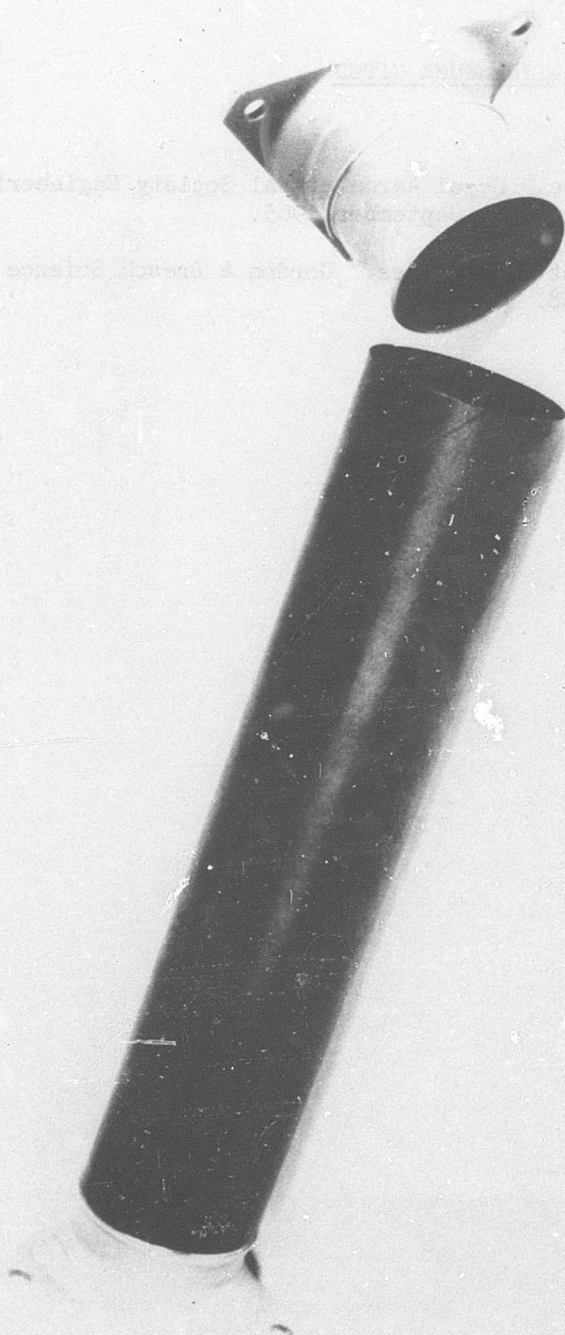
TAIL ROTOR DRIVE SHAFT

Figure 1. Boron/Epoxy Drive Shaft.

The original development work concentrated on using $\pm 45^\circ$ boron/epoxy laminates in single-wall construction as shown in Figure 1. Single-wall tube sections were tested in pure static torsion, but the results were not as encouraging as expected when compared with metal shafts. The strength of the single-wall composite tubes was severely limited by the instability of the thin walls. The stiffened wall concept of sandwich construction then evolved. This double-wall honeycomb structure, shown in Figure 2, proved to be much stronger than both single-wall boron/epoxy and aluminum shafts. The results of the static tests are shown in Figure 3. The test results showed that boron/epoxy sandwich construction yielded a 33 percent weight saving over that of conventional aluminum shafting.

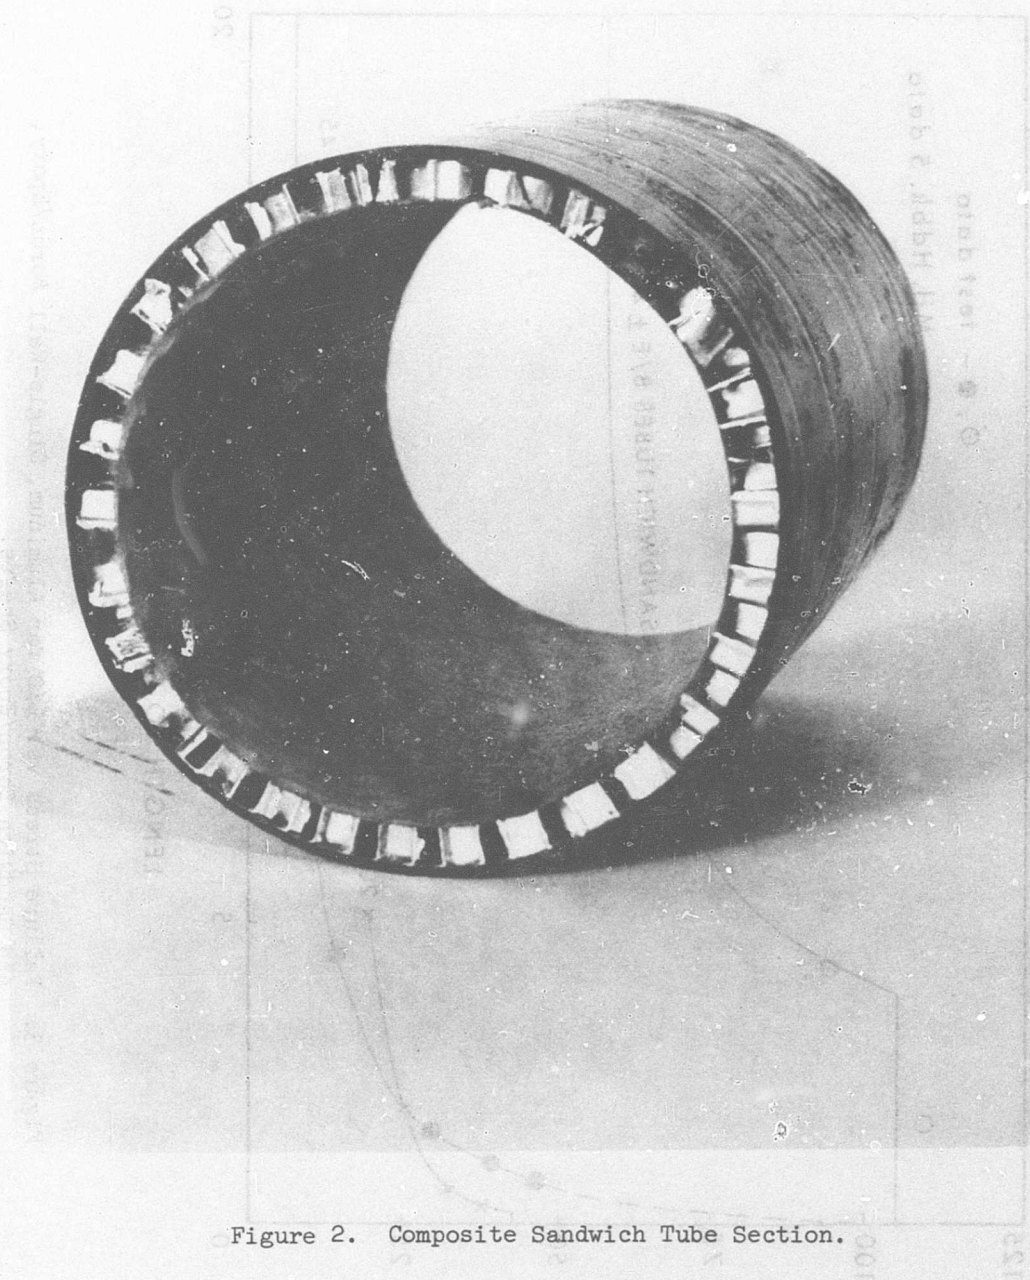
Figure 2. Composite Sandwich Tube Section.

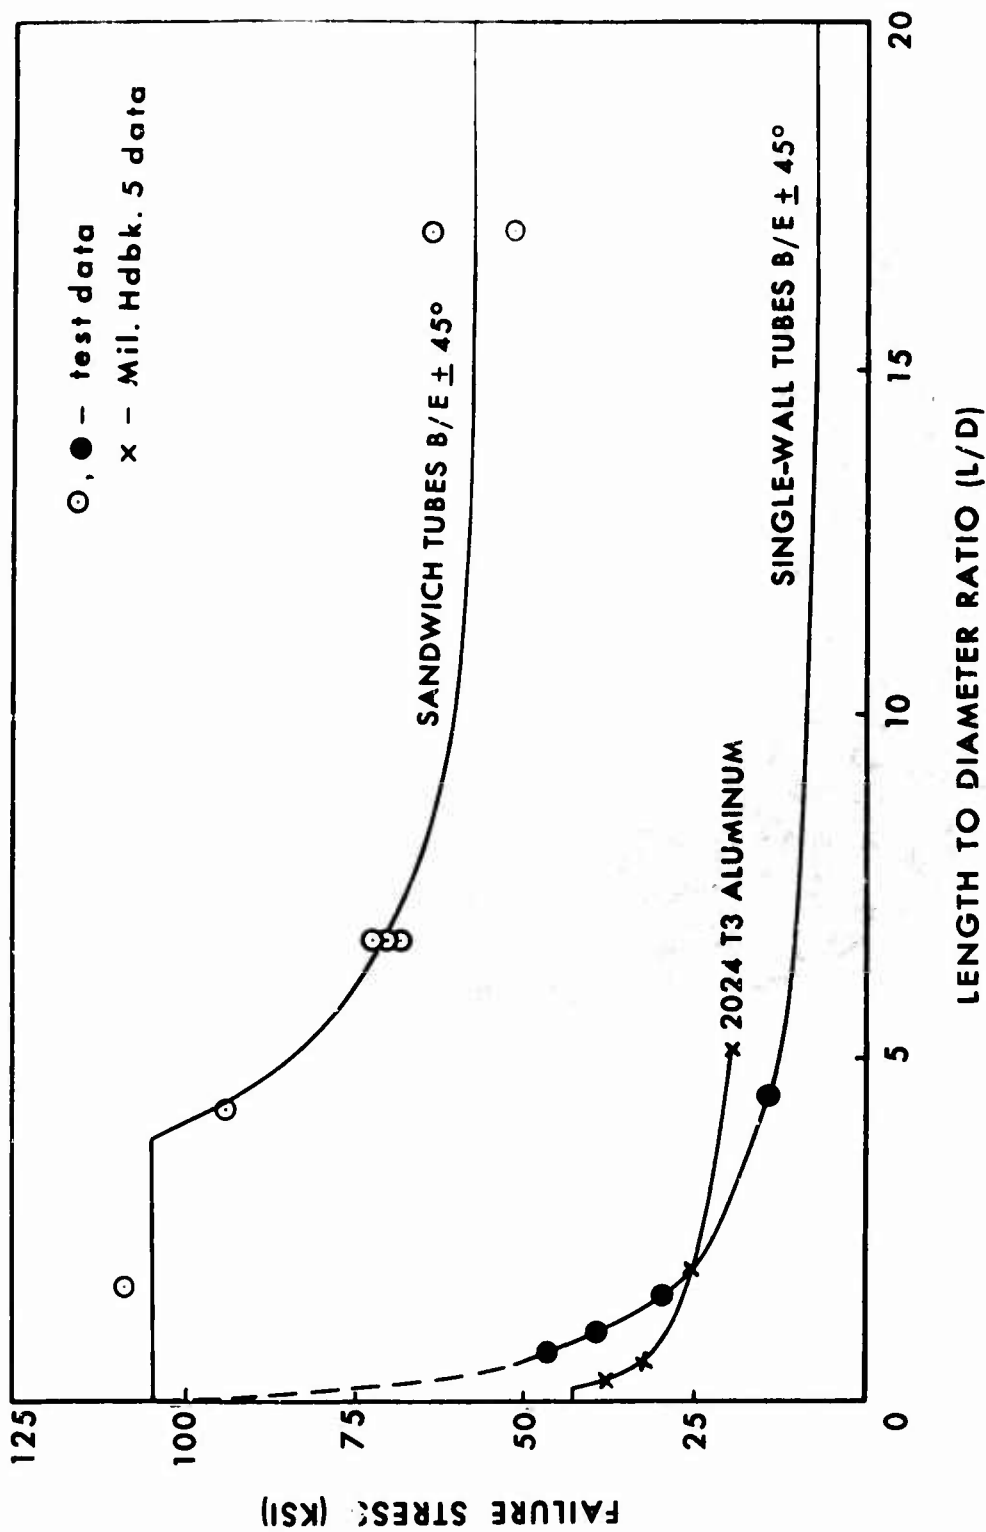
Figure 3. Failure Stress vs. L/D for Aluminum, Single-Wall Boron/Epoxy, and Sandwich Boron/Epoxy Shafts.

The strength of boron/epoxy drive shafts has been investigated in previous company-funded studies at Sikorsky Aircraft through static torsion testing of full-scale components. These tests have yielded strength data on failure shear stress as a function of length-to-diameter ratio (L/D) curves for both single-wall and double-wall (honeycomb sandwich) shafts, as seen in Figure 3. For comparison, the data for conventional aluminum shafts is also shown. It is readily seen that much higher stresses can be achieved in the sandwich tubes, permitting more efficient, lighter weight designs.

The point to be noted for this discussion of ballistic tolerance is the ultimate shear strength capability of the boron/epoxy shafts, indicated by the flat part of the curve in Figure 3. Below an L/D of approximately 3.5, the shafts fail due to material ultimate strength. Above this L/D value, torsional stability governs the failures, and the shaft capability depends on the tube geometry. It is seen in Figure 3 that the ultimate shear stress of boron/epoxy shafts ($\pm 45^\circ$ fiber orientation) is approximately 100,000 psi, which is consistent with theory stating that ultimate shear strength is approximately one-half ultimate tensile strength (200,000 psi for boron/epoxy). It is expected, therefore, that failure will occur when the ballistic damage produces local shear stress concentrations exceeding 100,000 psi.

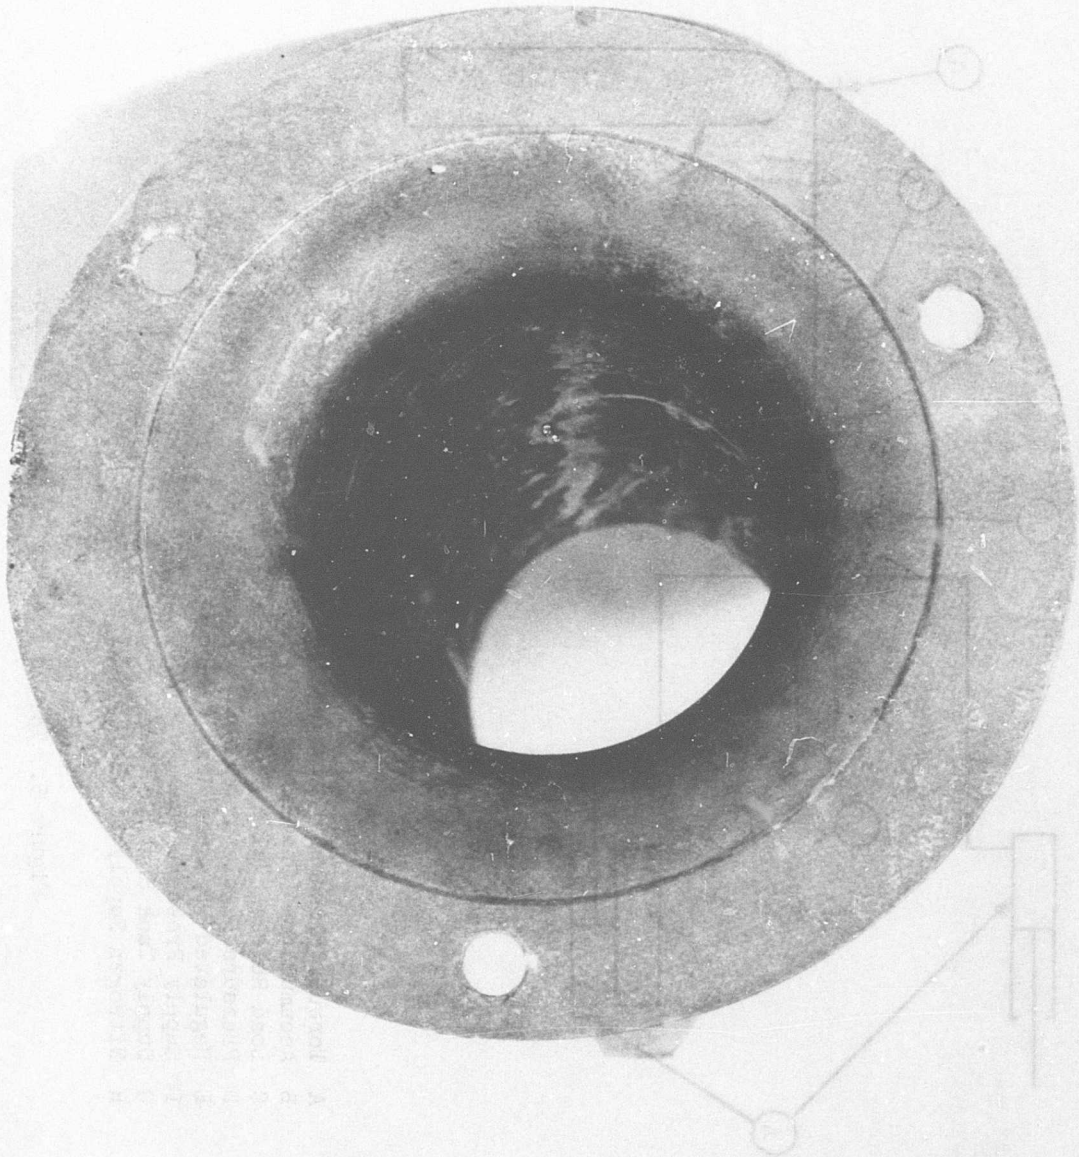
Figure 4. Composite Integral End Flange.

In an additional company-funded effort to reduce the weight of drive systems, a composite integral end design was developed by Sikorsky Aircraft. The integral end, shown in Figure 4, has been static torsion tested and has exhibited strengths exceeding that of long shaft sections. The use of composite integral ends increases the tube assembly weight saving to 40 percent. Further weight savings can be obtained by designing longer shaft sections with fewer bearings. The longest section tested to date is 57 inches, which is the span used on existing Sikorsky models. Longer shaft lengths, by reducing the number of bearing supports and end couplings, also reduce the vulnerability of the overall subsystem. Previous screening ballistic tests of double-wall tubes, not under load, showed little damage after impact. This observation prompted the present study to assess the effects of ballistic impacts on composite sandwich shafts under actual loading conditions.

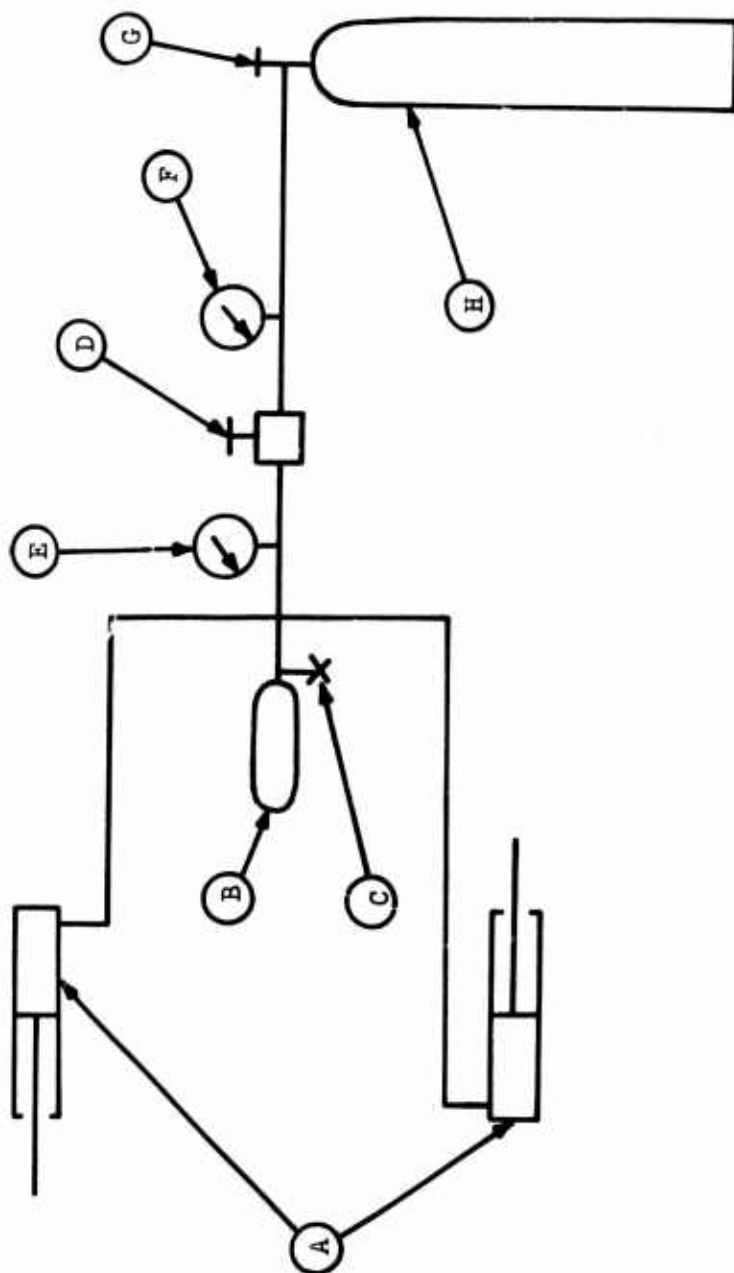
A Torque Cylinders (Existing Part of Test Fixture)
 B Accumulator (One Gallon)
 C Load Release Valve
 D Pressure Regulator (0 - 1000 PSI)
 E Regulated Pressure Gage (0 - 600 PSI)
 F Supply Pressure Gage (0 - 3000 PSI)
 G Supply Tank Shutoff Valve
 H Nitrogen Supply Bottle (253 CF @ 2200 PSI)

Figure 5. Torque Loading System Schematic.

A schematic of the loading system is shown in Figure 5. The equipment and test specimens supplied by Sikorsky Aircraft included the following:

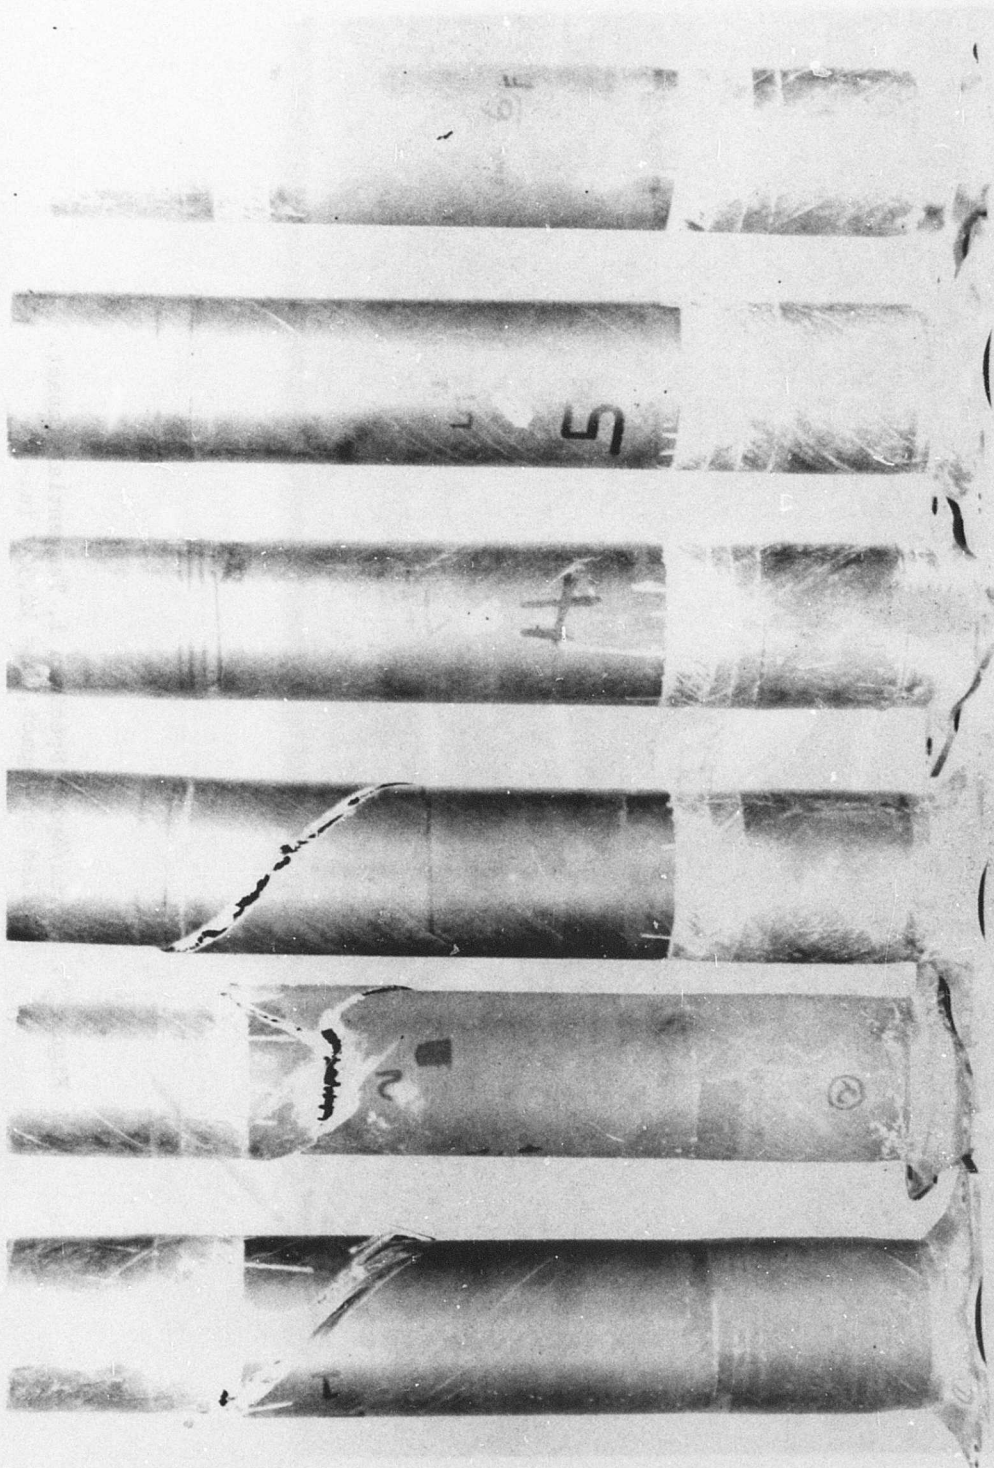
Figure 6. Composite Shafts After Ballistic Tests.

Photographs of ballistically damaged specimens are seen in Figures 6 through 23. The shaft numbering system corresponds to that contained in Table I. An investigation of the tubes indicates that the actual damaged area is less on the composite shafts than on the aluminum shafts. This can be seen by examining Figures 11 through 23. Composite specimens 4, 5, and 6, which sustained the load on impact, exhibit relatively small holes with little adjacent fiber damage. The long composite specimen also shows a small damaged area (see Figures 16 and 17). In contrast, however, the aluminum shafts have larger holes with flowering and sharp corners. In all cases the damage was greatest for tumbled shot at high velocities.

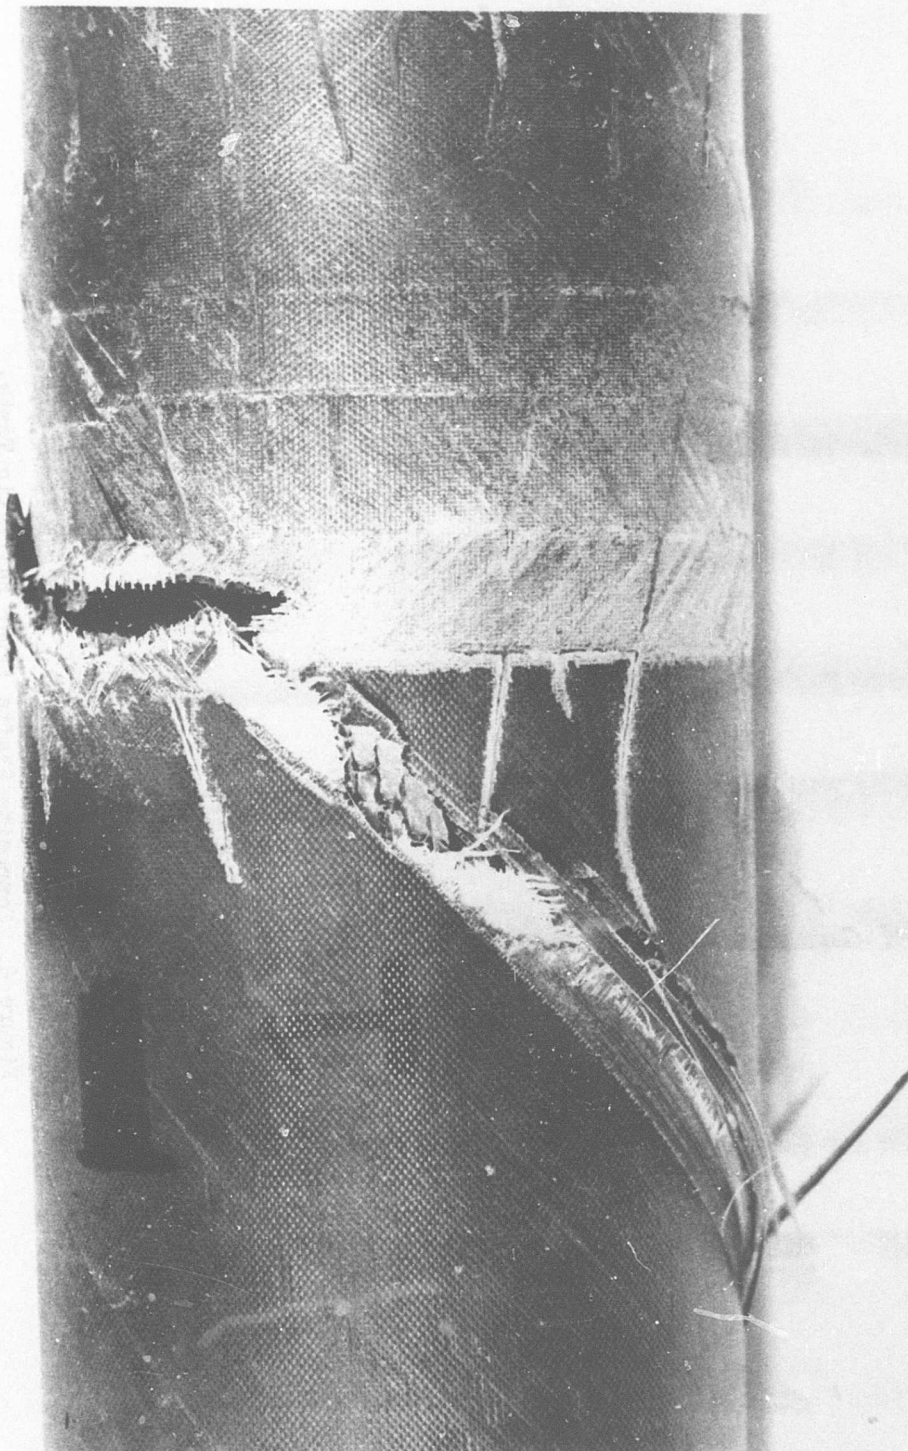
Figure 7. Boron/Epoxy Specimen 1, Tangential Impact.
Failed on Impact, $T = 12,300$ in.-lb.

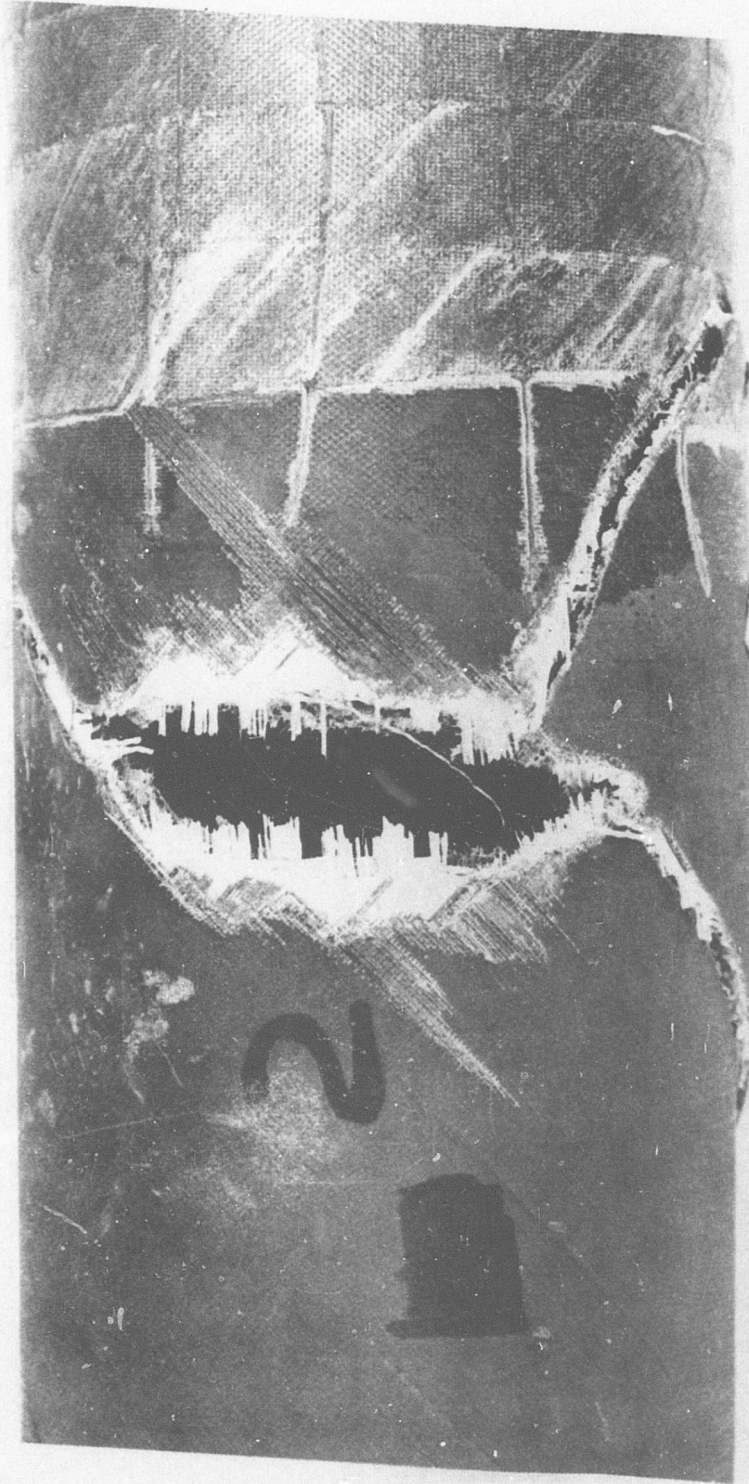
Figure 8. Boron/Epoxy Specimen 2, Tangential Impact.
Failed on Impact, $T = 8,200$ in.-lb.

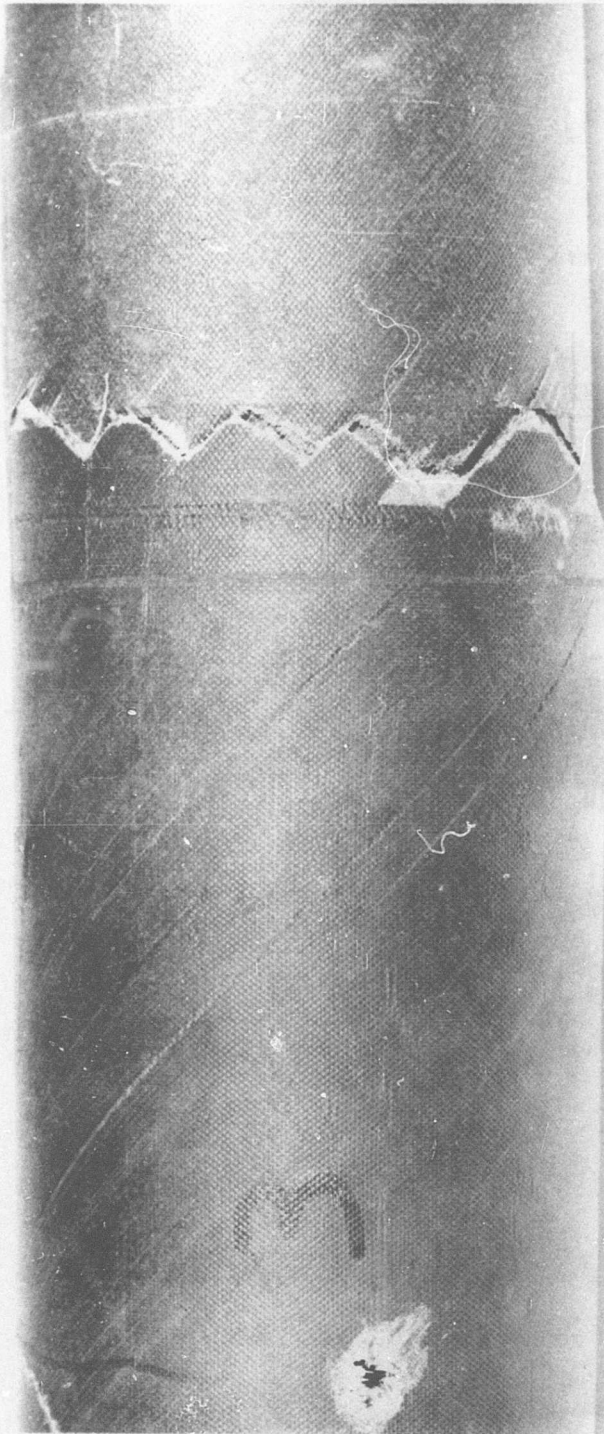
Figure 9. Boron/Epoxy Specimen 3, Entrance Hole Damage.
Failed on Impact, $T = 10,000$ in.-lb.

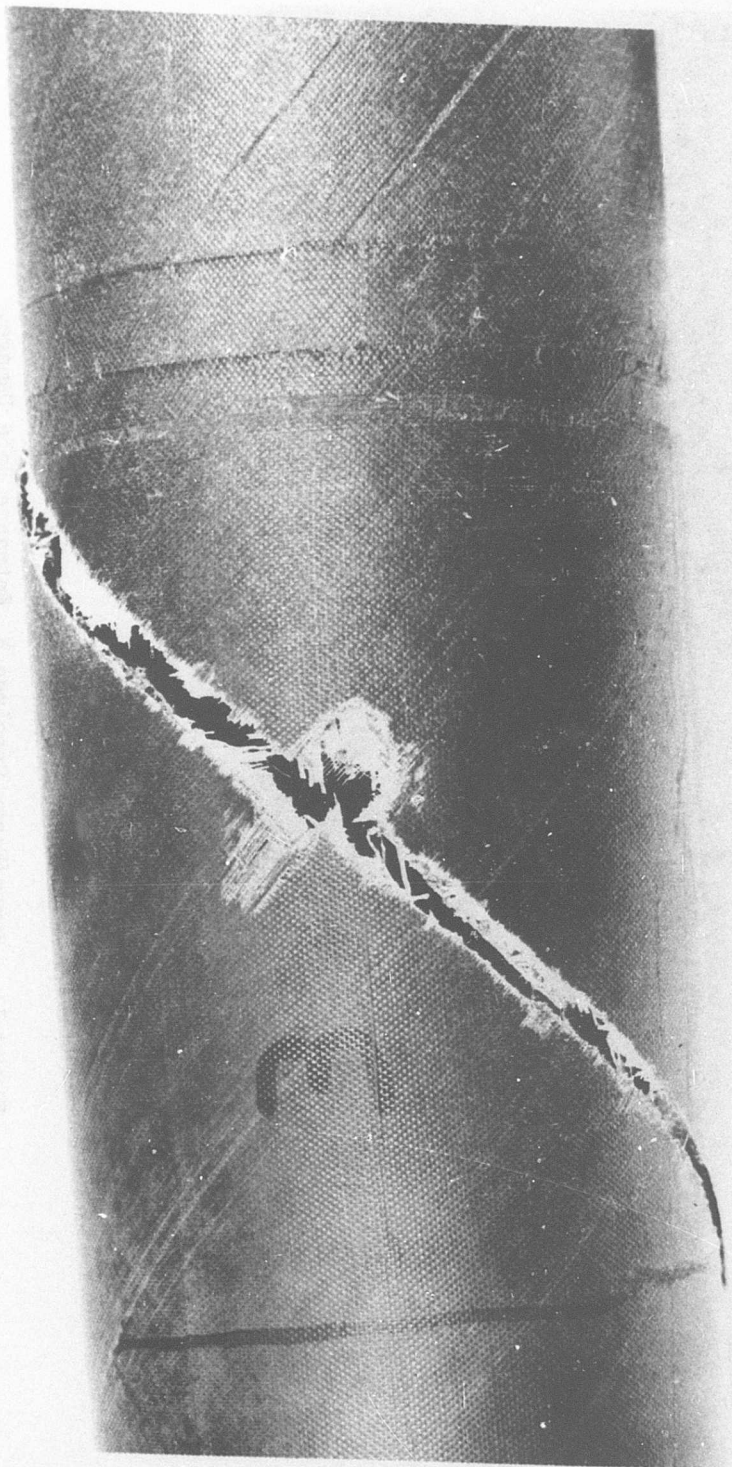
Figure 10. Boron/Epoxy Specimen 3, Exit Hole Damage.
Failed on Impact, $T = 10,000$ in.-lb.

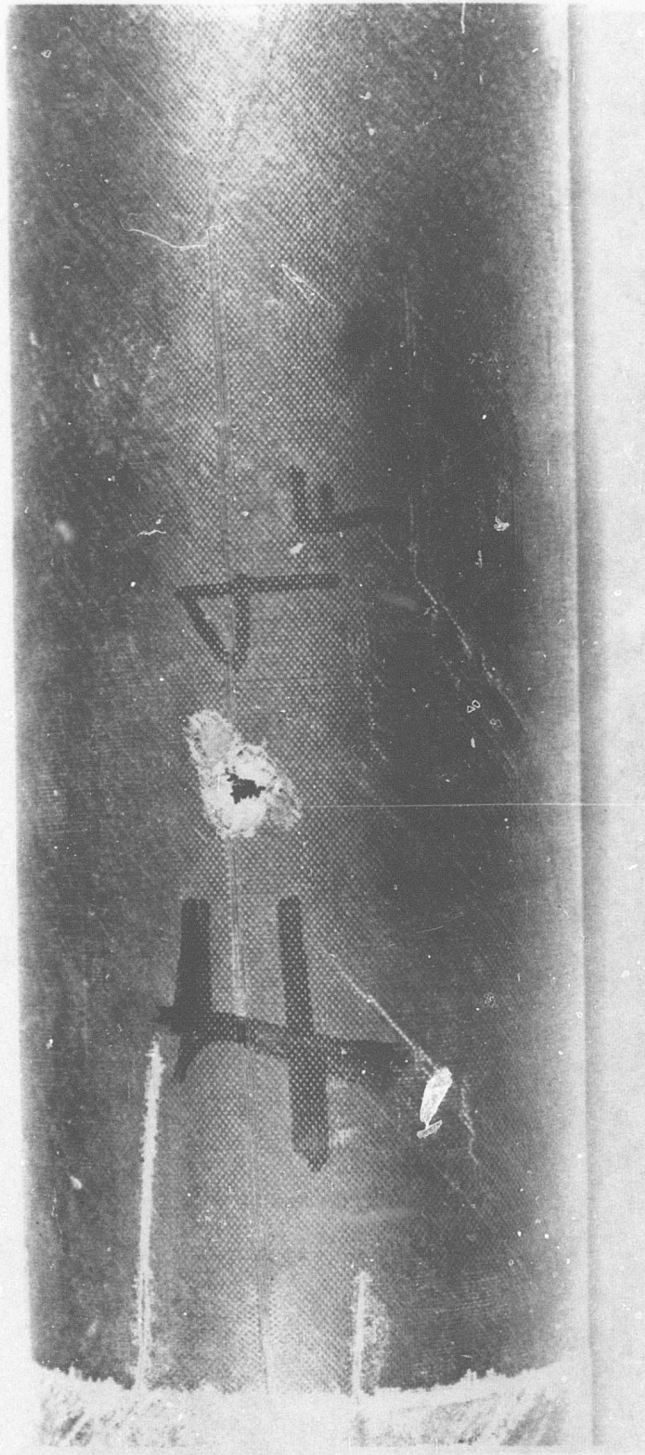
Figure 11. Boron/Epoxy Specimen 4, Entrance Hole Damage.
Torque on Impact = 7,500 in.-lb,
Residual Strength = 8,240 in.-lb.

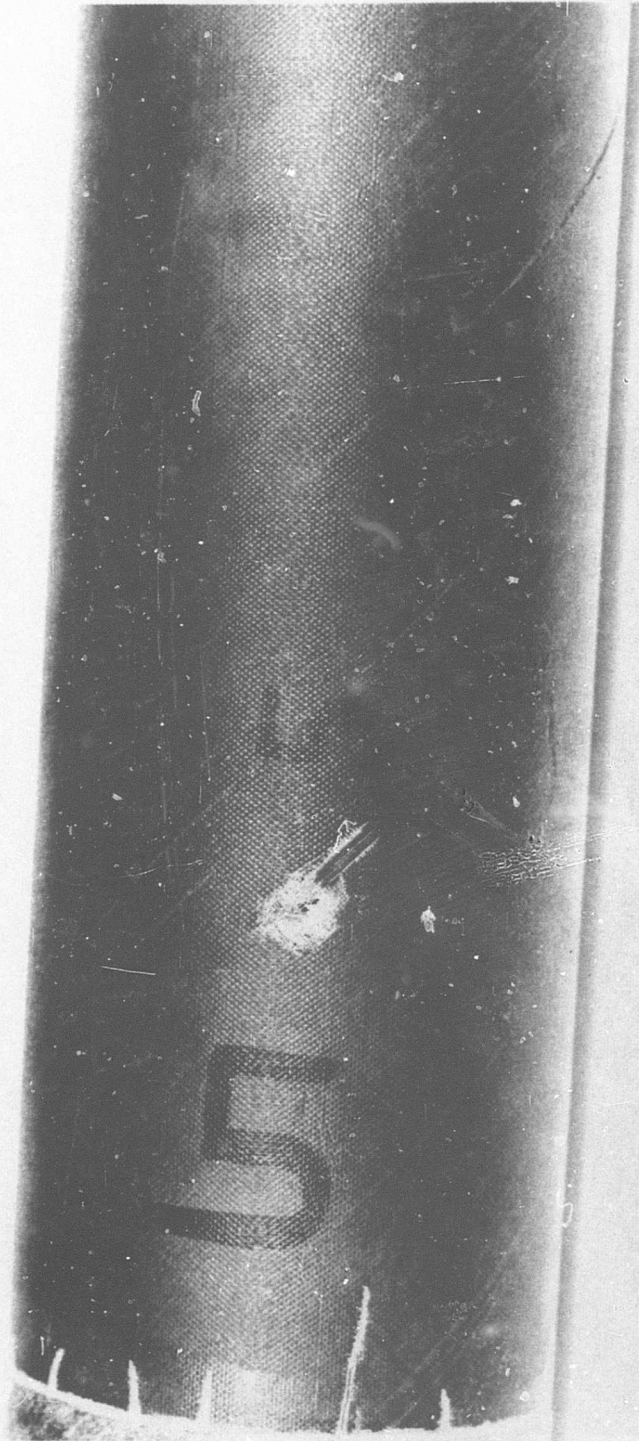
Figure 12. Boron/Epoxy Specimen 5, Entrance Hole Damage.
Torque on Impact = 7,500 in.-lb,
Residual Strength = 7,780 in.-lb.

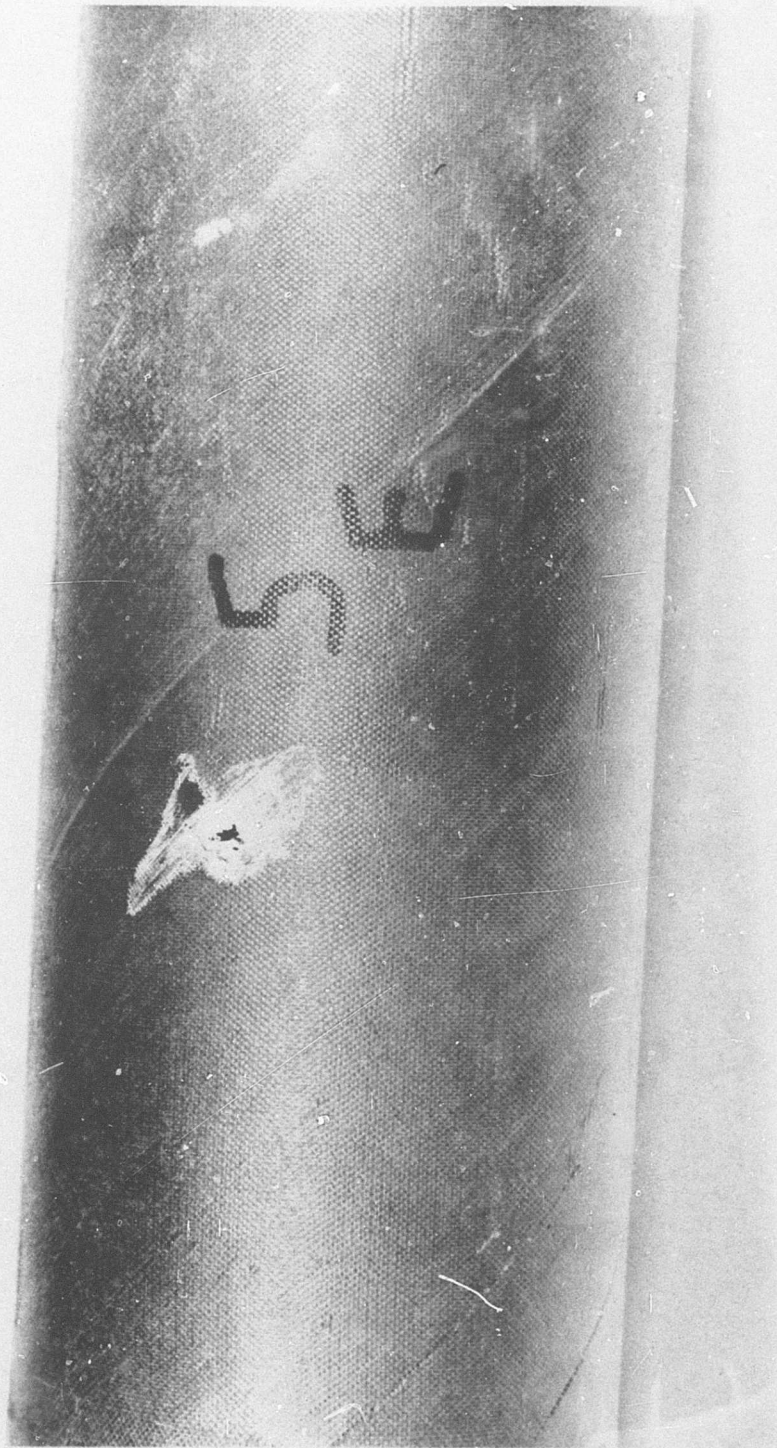
Figure 13. Boron/Epoxy Specimen 5, Exit Hole Damage.
Torque on Impact = 7,500 in.-lb,
Residual Strength = 7,780 in.-lb.

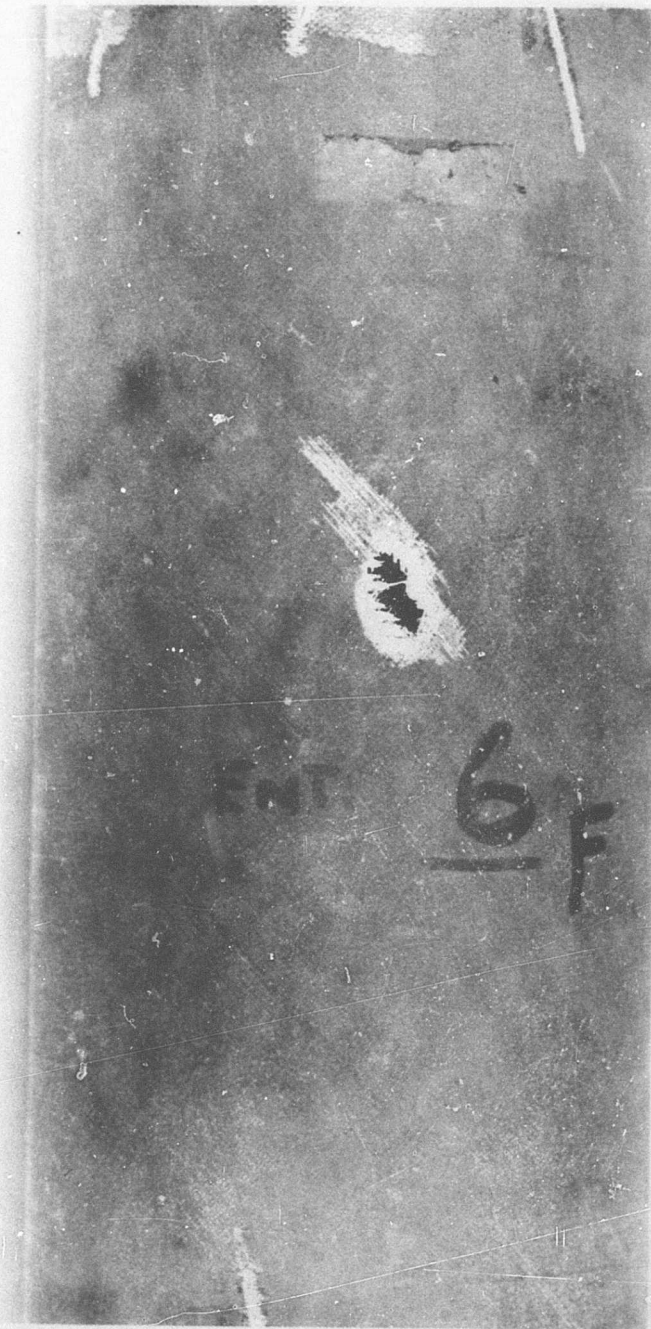
Figure 14. Boron/Epoxy Specimen 6, Entrance Hole Damage.
Torque on Impact = 7,500 in.-lb,
Residual Strength = 7,000 in.-lb.

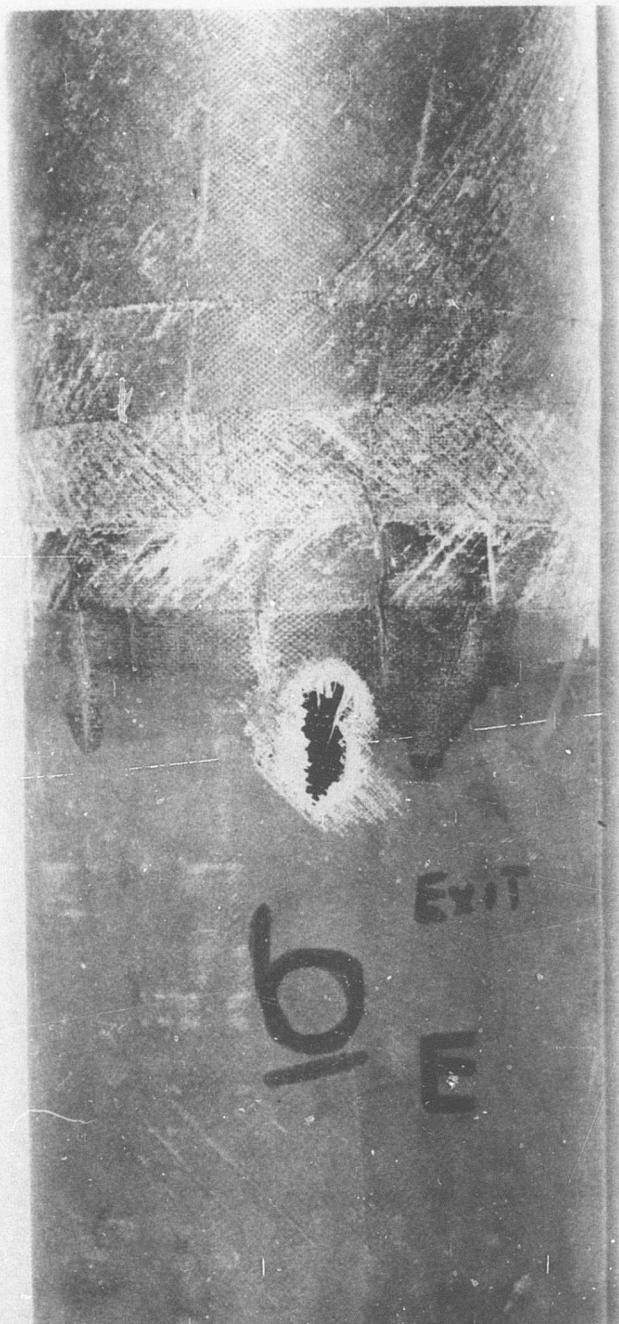
Figure 15. Boron/Epoxy Specimen 6, Exit Hole Damage.
Torque on Impact = 7,500 in.-lb,
Residual Strength = 7,000 in.-lb.

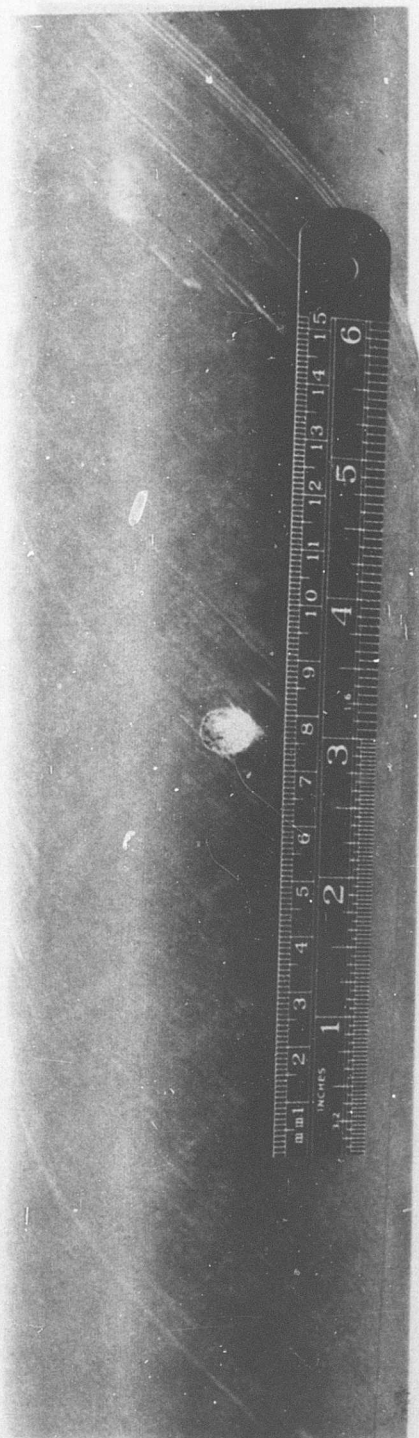
Figure 16. Boron/Epoxy Specimen 7, $L = 45.9$ inches, Entrance Hole Damage.
Failed on Impact, $T = 10,000$ in.-lb.

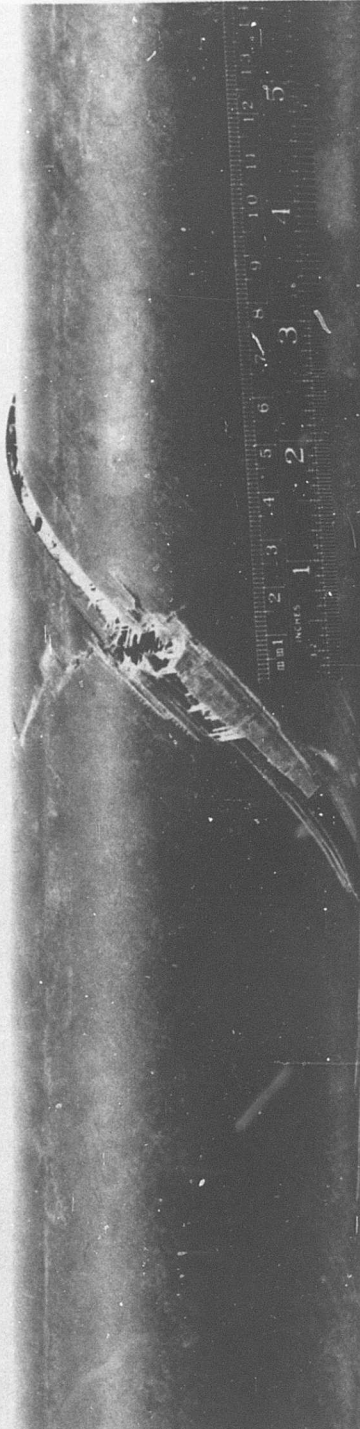
Figure 17. Boron/Epoxy Specimen 7, $L = 45.9$ inches, Exit Hole Damage.
Failed on Impact, $T = 10,000$ in.-lb.

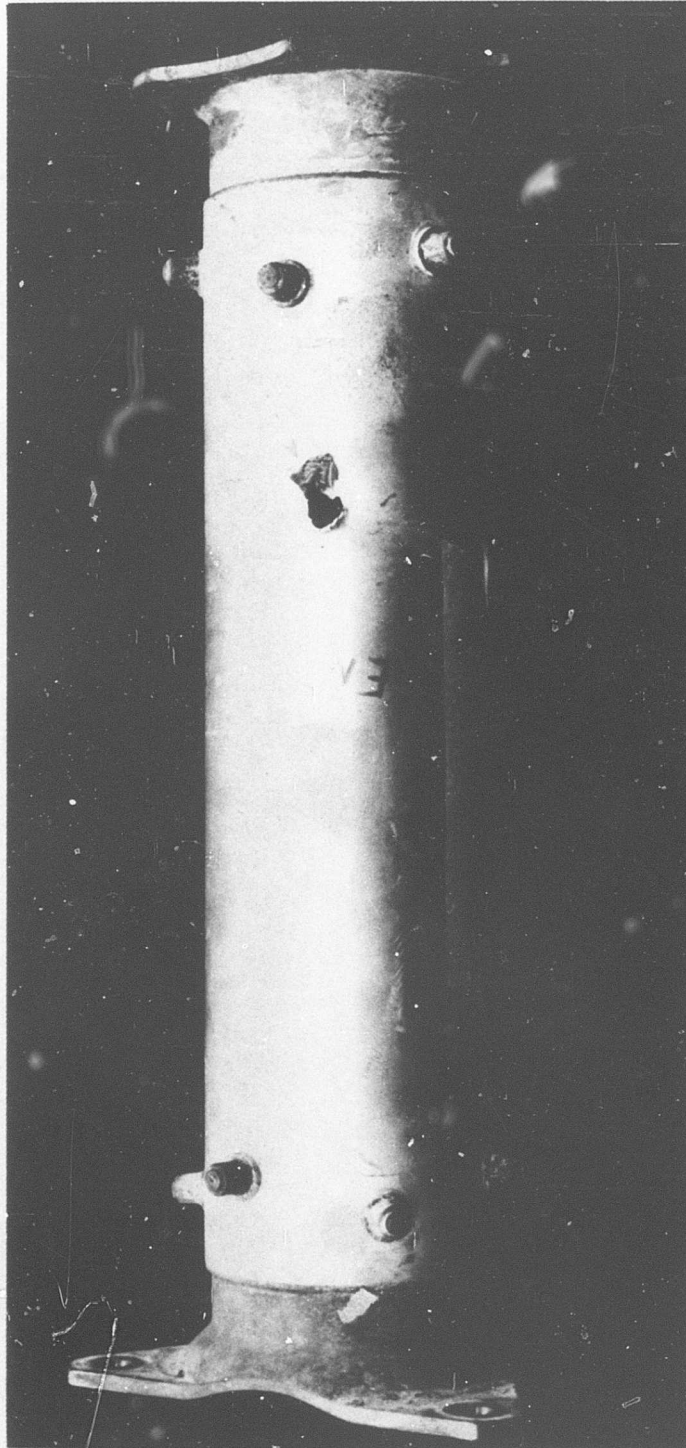
Figure 18. Aluminum Specimen 8, Entrance Hole Damage.
Torque on Impact = 10,000 in.-lb,
Residual Strength = 26,400 in.-lb.

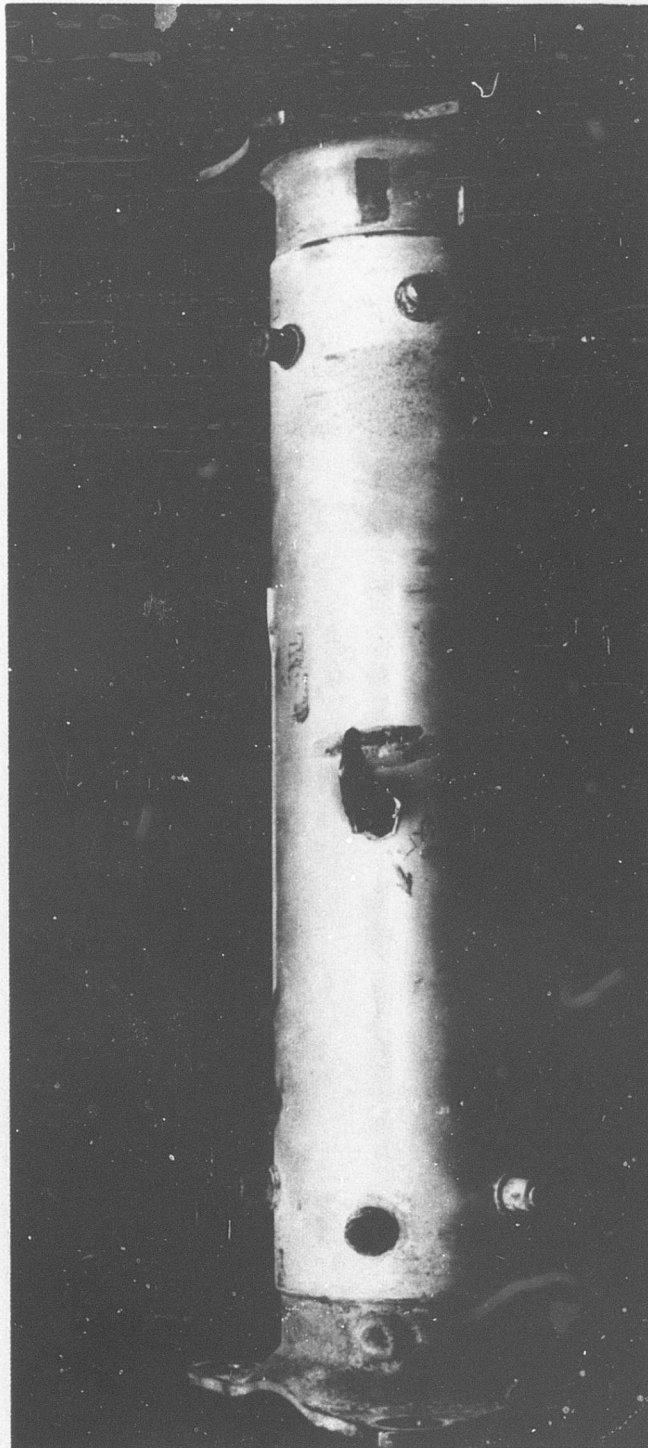
Figure 19. Aluminum Specimen 8, Exit Hole Damage.
Torque on Impact = 10,000 in.-lb,
Residual Strength = 26,400 in.-lb.

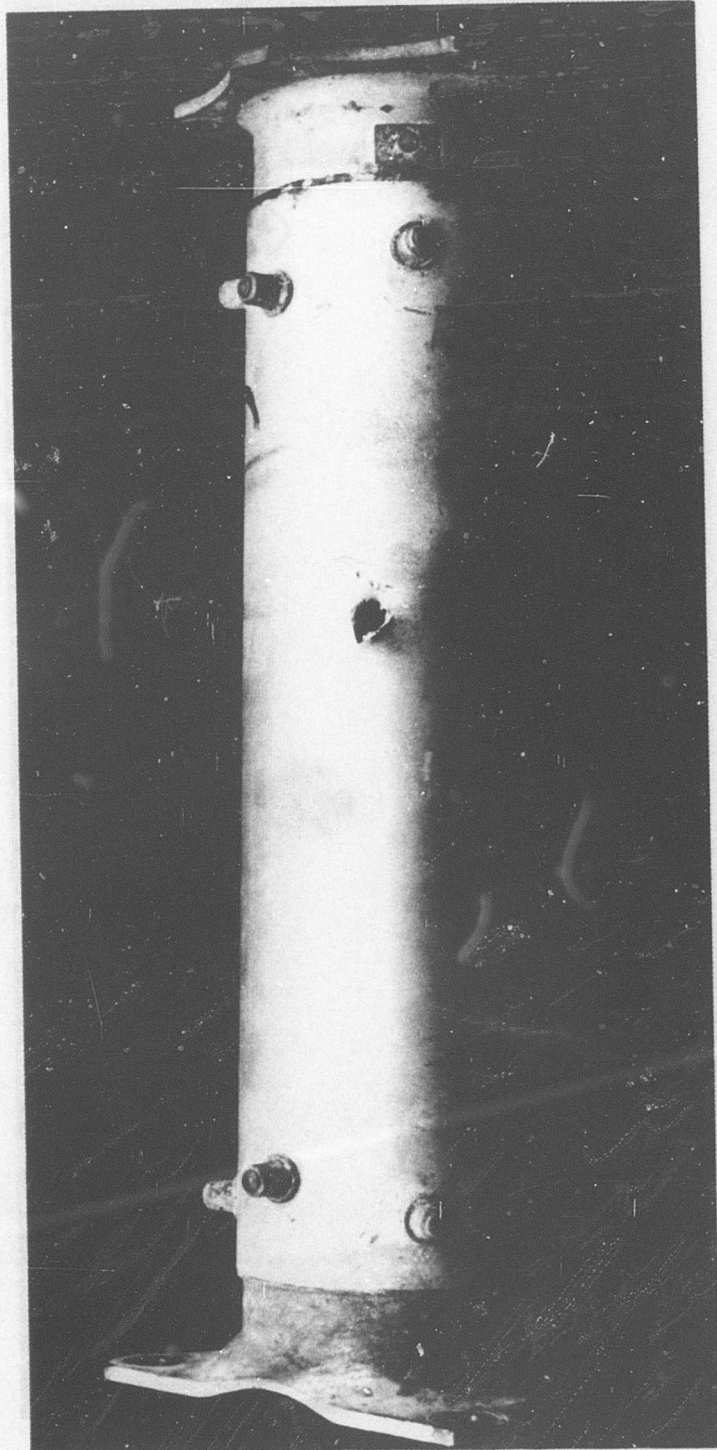
Figure 20. Aluminum Specimen 9, Entrance Hole Damage.
Torque on Impact = 13,000 in.-lb.
Residual Strength = 32,600 in.-lb.

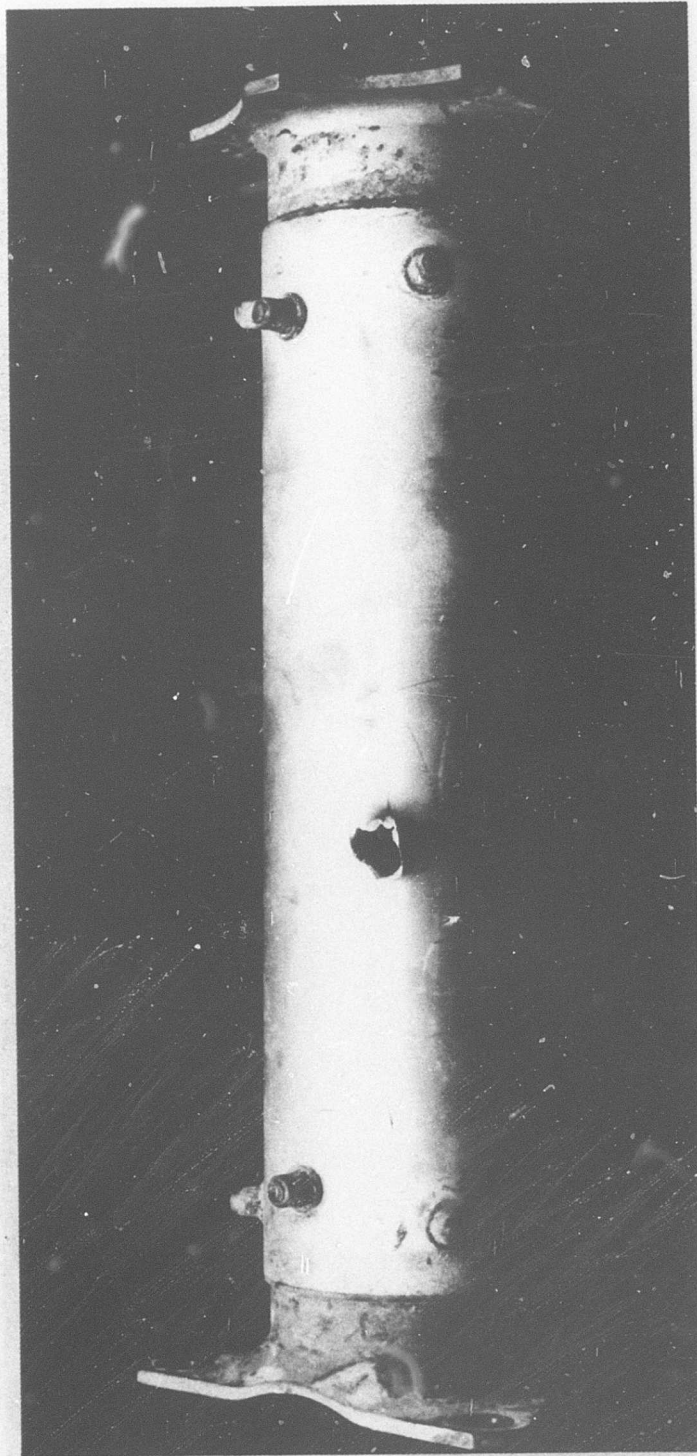
Figure 21. Aluminum Specimen 9, Exit Hole Damage.
Torque on Impact = 13,000 in.-lb,
Residual Strength = 32,600 in.-lb.
